ARCADIS

## Plainwell Project Status

## Project Summary

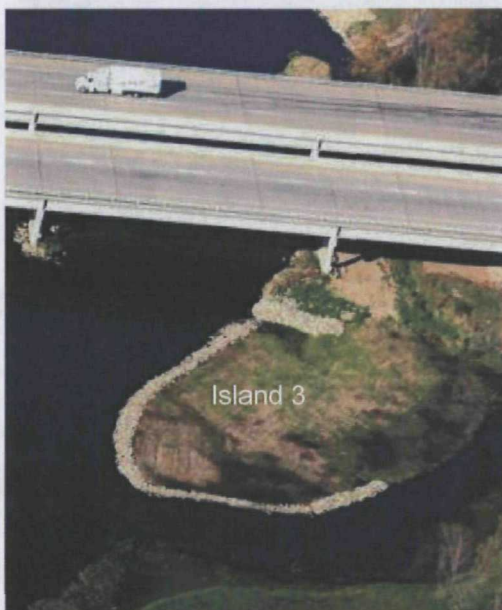
# Bank Stabilization Approaches

- Different bank stabilization approaches (soft vs. hard) used in different areas of the project site; slope no steeper than 3:1
- Remove three mid-channel sediment deposits with PCBs > 50 ppm

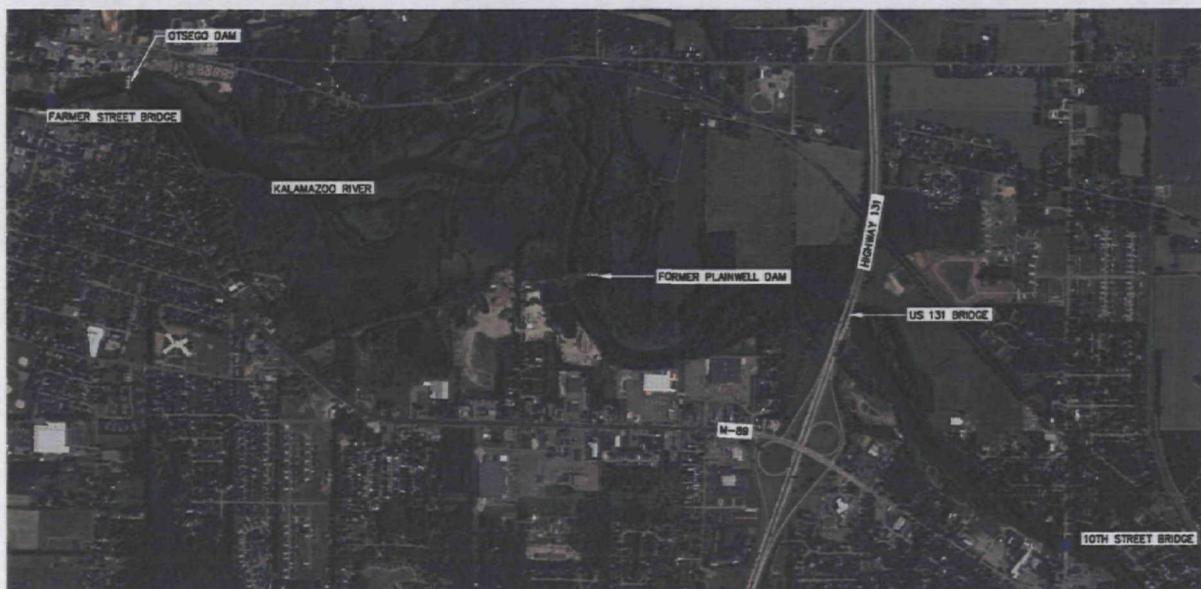
# Surface Water Monitoring Locations

- Objective: Quantify increase in solids and PCB loads in the river downstream of Plainwell, if any, that may be attributable to construction activities
- Samples collected every other day during active construction
  - Upstream – 10<sup>th</sup> Street Bridge in Plainwell
  - Downstream – Farmer Street Bridge in Otsego
  - October 2007 – December 2007: 37 sample pairs
  - March 2008 – January 2009: 139 sample pairs
- 402 total samples collected – 398 non-detect results
  - Maximum value 0.19 ug/L from upstream
- Data show no discernable contribution to solids or PCB transport resulting from construction activities

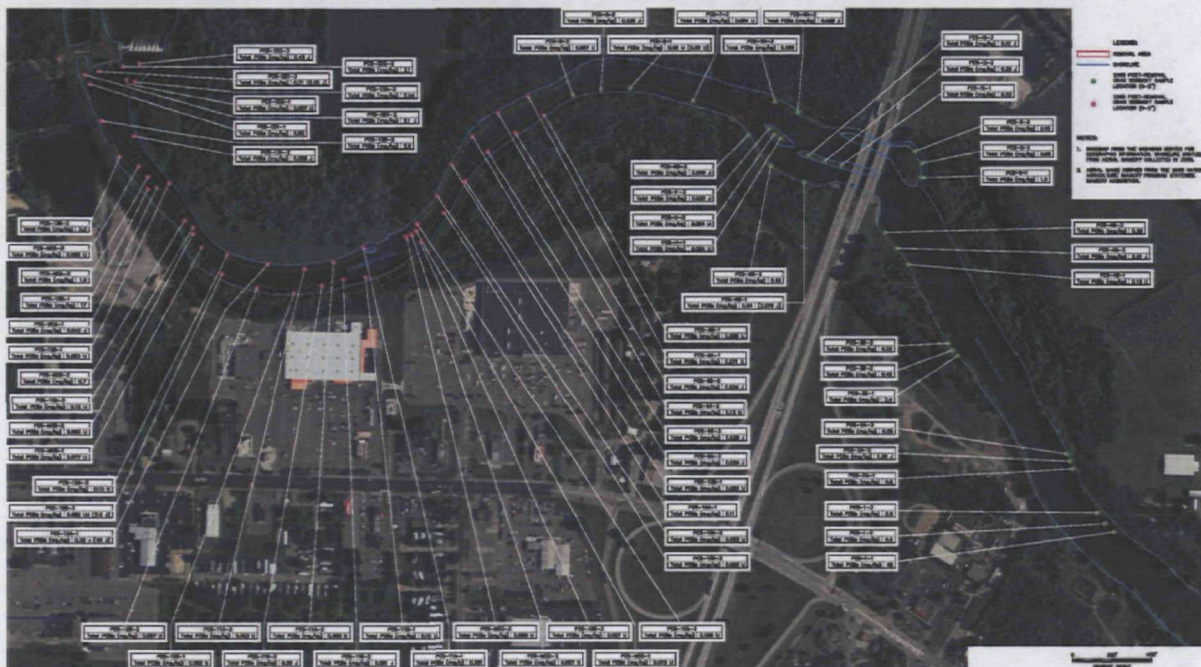
# Post-Removal Surface Sediment Sampling 2008 and 2009 Results

- Objective: measure post-construction sediment PCB concentrations for use in risk assessments
- 80 surface sediment (0-2 inch depth) samples collected at 75 locations in 26 removal areas
  - January 2008: Removal Areas completed in 2007
  - March 2009: Removal Areas completed in 2008
- 41% of samples: PCBs not-detected
- 81% of samples: PCB concentration < 1 mg/kg
- Three highest values all from Removal Area 1

Statistic	Value
Range	ND – 48 mg/kg (at PCS-1-1)
Median	0.061 mg/kg
Average	1.7 mg/kg
Average excluding PCS-1-1	1.1 mg/kg
